CASE REPORT

INTRALUMINAL OBSTRUCTION OF ARMoured ENDOTRACHEAL TUBES-ARE REUSED TUBES KINKFREE BUT OBSTRUCTION PRONE!

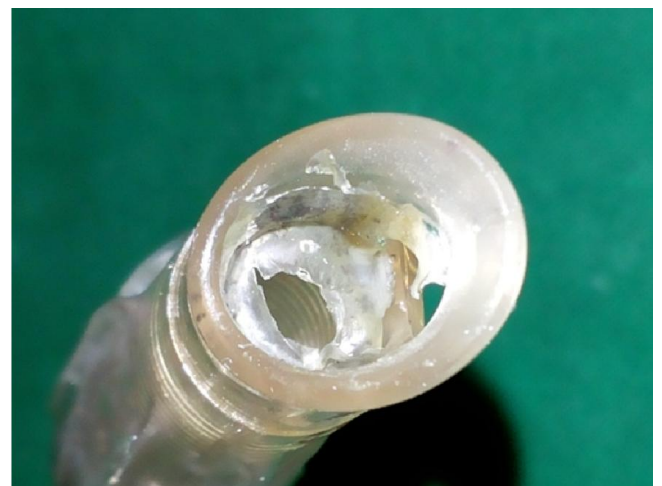
inspection of armoured tube revealed circumferential reduction in the diameter near distal end due to presence of glistening white crust material (Fig. 1).

Fig. 1. Circumferential narrowing and obstruction by mucus or local anaesthetic jelly

This could be removed in parts. Armoured endotracheal tubes are commonly reused after sterilization (Gurumurthy *et al.*, 2012). Although blockade of armoured tubes with external factors like mucus and patient bites have been reported, several cases of intraoperative obstruction due to inherent inner tube wall malfunctioning have also been noted

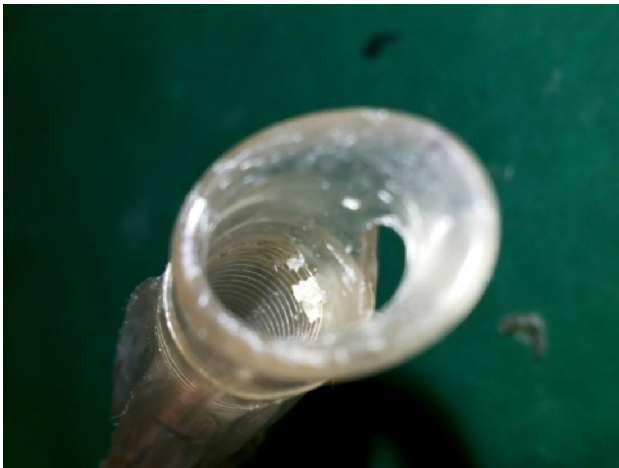
(Balakrishna *et al.*, 2010). Marcanoglu *et al.* have reported a tear of internal wall of the armoured tube leading to intraoperative obstruction. This was caused by the dissection of the wall in between the spiral rings (Mercanoglu *et al.*, 2013). Paul *et al.* reported an unusual case of armoured tube obstruction caused by a flap-like detachment of the inner coating from the spiral of a reinforced tube which acted like a valve. This was even undetectable by fiberoptic examination. Dissection of inner lumen, dislodgement of spiral rings and detachment of inner wall, internal blistering and bleb formation have all caused malfunctioning of armoured tubes leading to intraoperative obstruction. (Paul *et al.*, 2003; Jeon *et al.*, 2007; Rajkumar *et al.*, 2011; Dubey *et al.*, 2013; Tose *et al.*, 2003 and Rouco Martinez *et al.*, 1984). Although many similar cases like ours have been reported, we took a closer look of the design of the flexometallic tube for the frequent cause of tube blockade and high peak pressure with armoured tubes and inner wall trauma. The tip of the armoured tube differs from that a portex ETT in having thicker edge. This might predispose for retention of mucus secretions. Close inspection of the inner lumen of a flexometallic tube reveals serrations due to the metallic rings (Fig 2).

Fig. 2. The same tube after removal of crusts. Note the serrations in the inner wall and retained material corresponding to circular serrations

These serrations produce uneven surface and space for retention of mucus plugs or crusts of local anaesthetic jelly. The serrations might also cause turbulent flow and increased airway resistance. A closer feel reveals actually the outer wall of the armoured tube is more smoother than the inner wall. The serrations may also predispose to trauma to inner wall with suction catheter tips and use of styilet to intubate. Thus, there may be unnoticed trauma to the tube, especially the inner wall and these manifest with subsequent reuse.

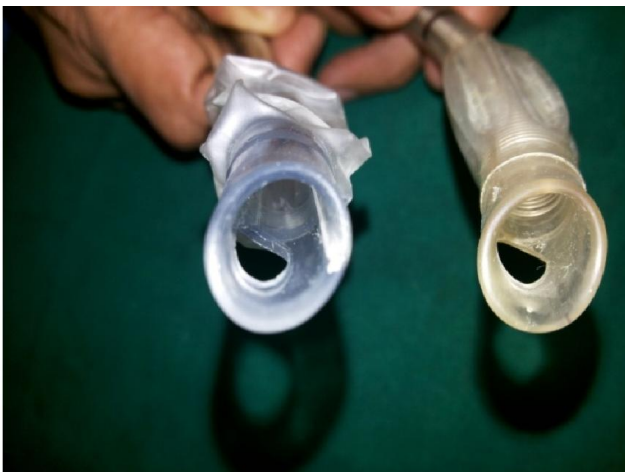
Fig. 3. The tip of portex tube and armoured tube compared. Note the thicker edge of armoured tube predisposing for retention of secretions

Some practical changes can be made to make the armoured tube less obstruction prone while maintaining the kinkfree property. The tip of the flexometallic tube be modified more thinner akin to the portex tube. This would make the armoured tube less prone for secretions to get stuck at the tip. If the spiral embeddings can be incorporated more towards the outer wall, this would make inner surface smooth. This can be safely achieved with additional reinforcement of the tube wall and gaps in between to prevent damage to spiral rings and patient trauma. During manufacturing of the spiral tubes, a rod is dipped in liquid polyvinyl chloride (PVC) creating a thin layer of PVC around the rod. The spiral is then mounted onto the rod and dipping process is repeated several times creating an outer coating on the spiral (Paul *et al.*, 2003).

We suggest the tip of the flexometallic tube be modified more thinner akin to other portex tube and the spiral embeddings can be incorporated more towards the outer wall and make inner surface smooth. If armoured tubes are to be reused, the best time to clean them thoroughly is immediately after extubation. Of course, this has to followed by regular check before next use.
